APPENDIX E

PREDRAINAGE LANDSCAPE ECOLOGY AND HYDROLOGY OF THE ST. LUCIE WATERSHED ESTIMATED FROM HISTORICAL SOURCES

Christopher McVoy, SFWMD

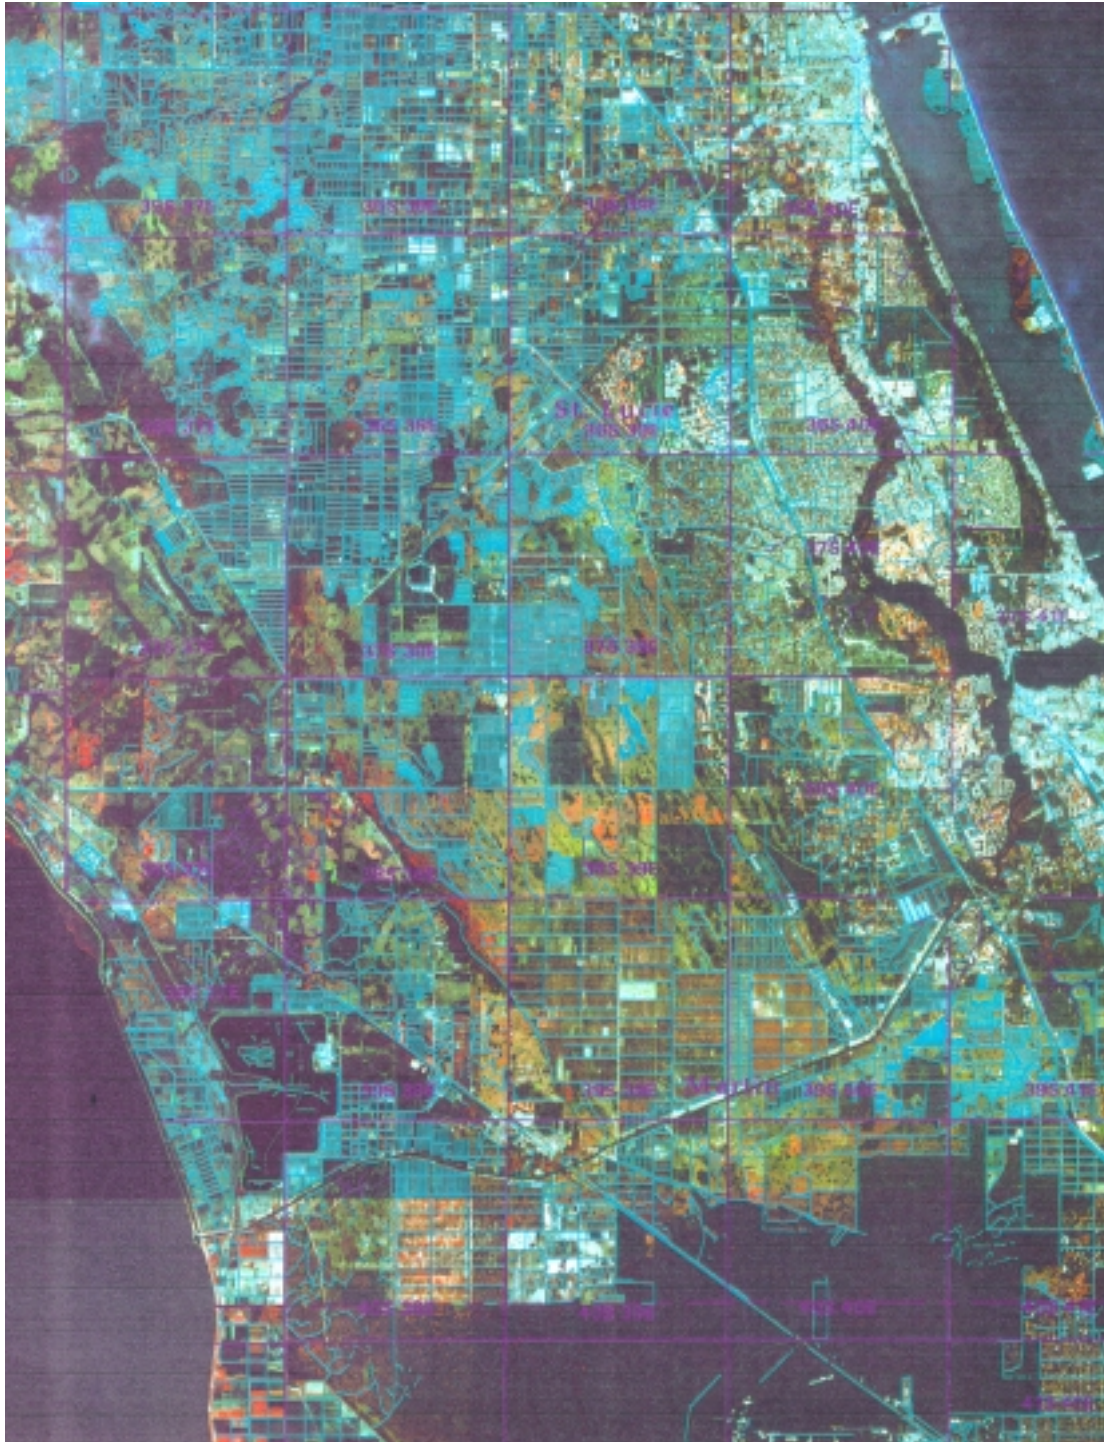
It is important to recognize from that outset that, by all indications, the St. Lucie River watershed has been extensively and intensively influenced by drainage. Almost every square mile is traversed by numerous drainage canals and ditches (**Figure E-1**). It is also important to recognize that historical information (e.g., Randolph et al., 1919), as well as the accessibility of the landscape, suggest that significant drainage was in place

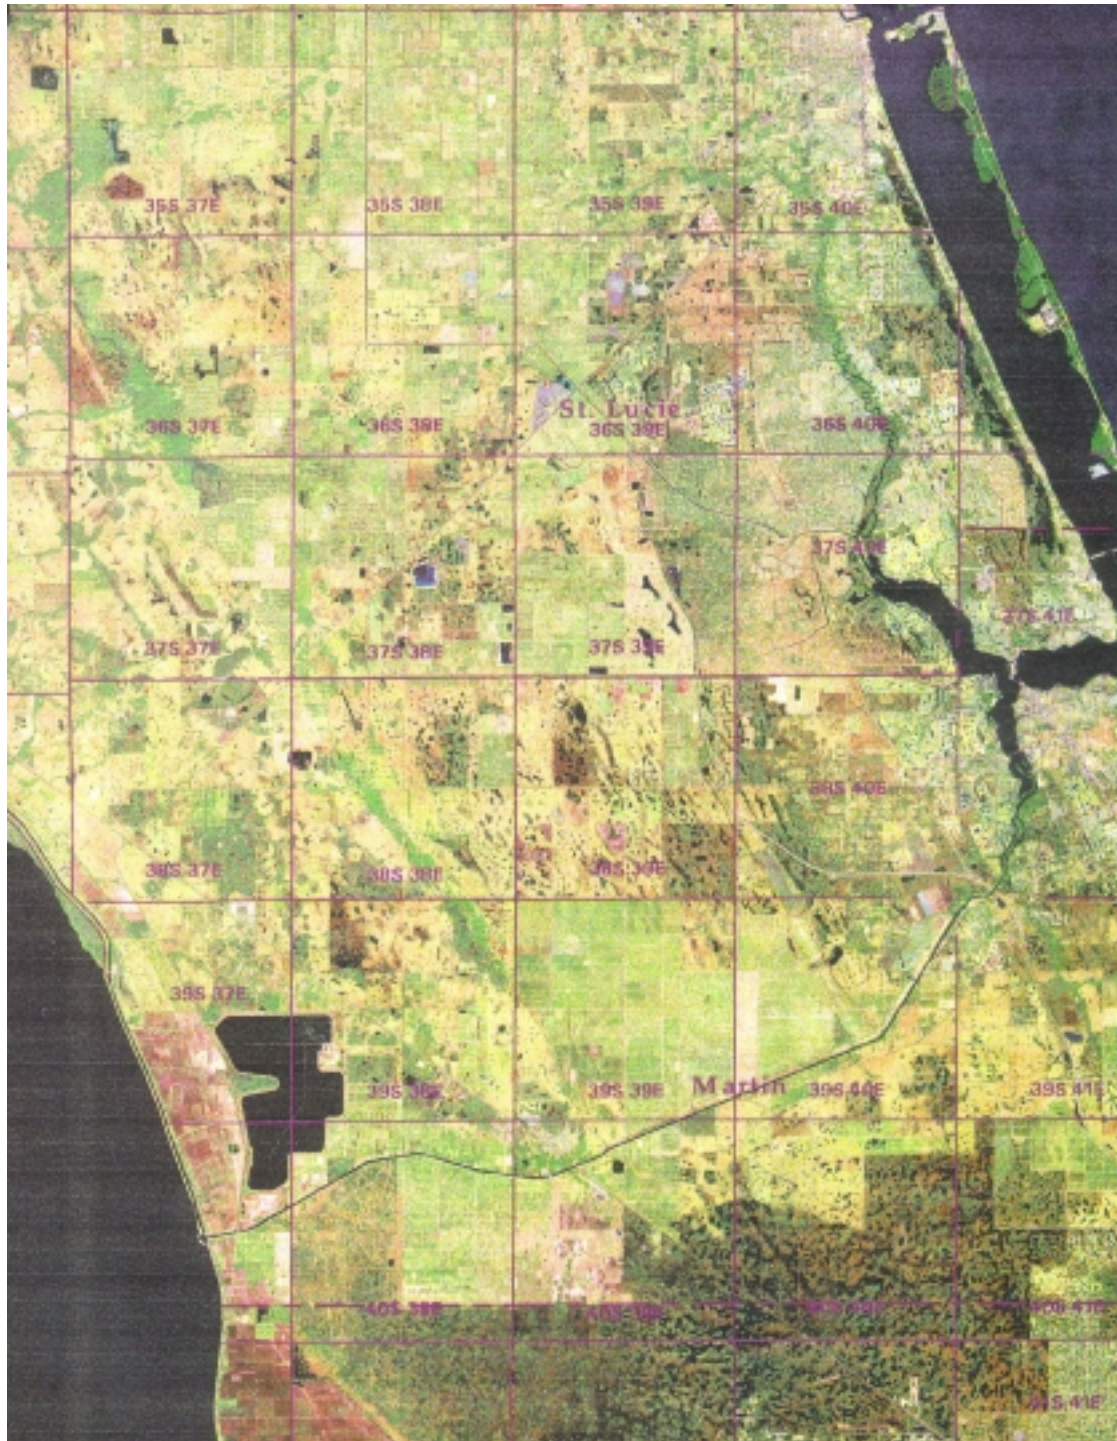
Figure E-5. Satellite Image of the Northwestern Portion of the St. Lucie River Watershed, with Township Range Grid (note relation of land use to the township range grid)

This brief reconnaissance study was initiated by examination of a satellite image overlain with a township range grid (**Figure E-5**). By inspection, four townships ranging from north to south within the watershed were selected, based on the remaining presence of original mosaic pattern (townships outlined in red on **Figure E-5**). The four townships were also selected for their alignment with the prevailing northwest to southeast pattern, possibly related to relict sand dunes. It was necessary to include an additional southern township (Township 40, Range 38), as field notes were not available for Township 40, Range 40.

With the exception of one or two townships on the southern border of the watershed, Township 38, Range 39 appears to be the least developed (**Figure E-5**) of the five, lending itself to comparisons between present day topographical maps and the 130-year old township plat map. Regional drainage almost certainly affects the township, but local ditch systems seem to be less developed here than elsewhere in the watershed (**Figure E-1**). The survey notes are repetitively consistent, all “3rd Rate Pine & Ponds” with pines as witness trees. Comparison of the township plat map (**Figure E-2**) with the USGS Andantino NW topo quad map (**Figure E-3**) suggests a close match in wetland delineation. The hammock found on the Section 15-22 border appears to still be present
